Test Report No.: SDHL1606010781FT Date: Jul.01, 2016 Page 1 of 3

Too, House, Culturally	
Test(s) Requested	Result(s)
Gas spring durability test (80,000 cycles)	PASS
Summary:	
 For further details, please refer to the following page(s).

Gas spring durability test as per client's requirements

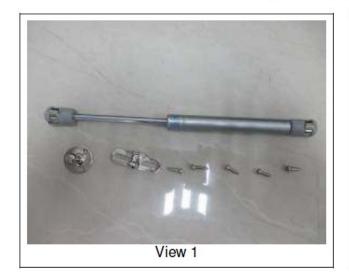
Weight: 65.0 g

Overall Dimensions: 228.59 mm (L) x 5.96 mm (Dia.) x 14.86 mm(Dia.)

Sample as Received
